Inspection Report

Inspector: Jason Hornung

123 Anywhere Road

Your town, Md

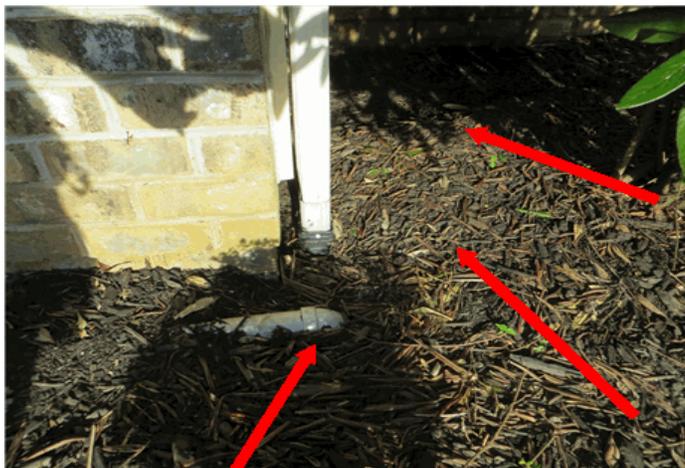
1) Grading Conditions

Minor re-grading near the foundation was observed. We recommend re-grading to assure all water drains away from the home's foundation. Failure to re-grade low-lying areas at the foundation can cause water seepage under slabs, into the basement, and / or cracks or movement in the foundation. It is suggested that a "Licensed Landscaping Contractor" be contacted for further evaluation and repair.

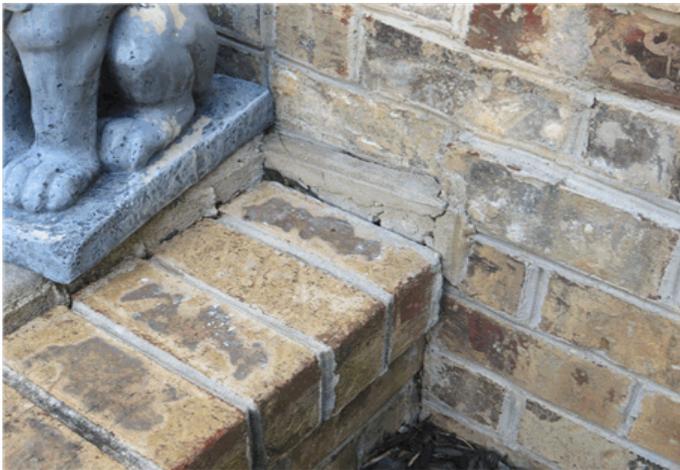
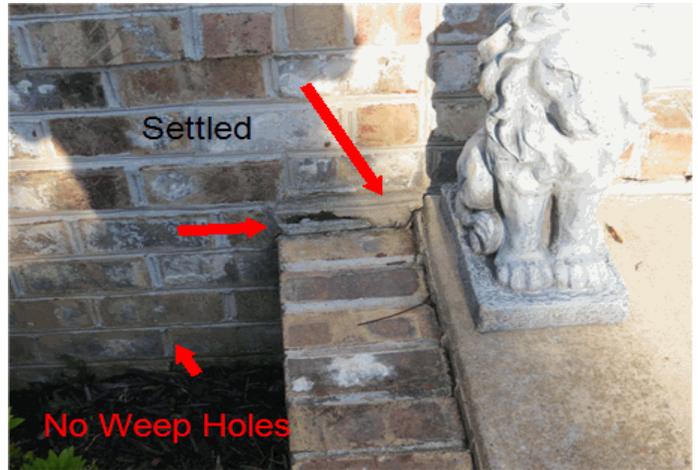
5) Front Entrance Conditions

Settlement was observed. Sealing and some repair may be warranted. It is suggested that a "Licensed Masonry Contractor" be contacted for further evaluation and repair.

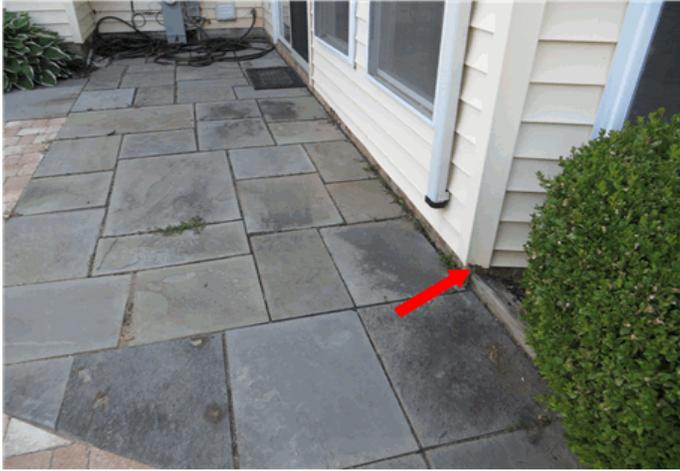
7) Exterior Wall Conditions

No weep holes or provisions for drainage were observed at brick or masonry veneer. Today's standards generally require weep holes in the grout at bottom of walls and under flashings for drainage of water or condensation. Minor damage to the corner trim was observed. Vegetation was in contact with the exterior walls. The vegetation should be trimmed away 1 - 2 feet from the wall. The exterior walls

were not fully visible due to overgrown vegetation.

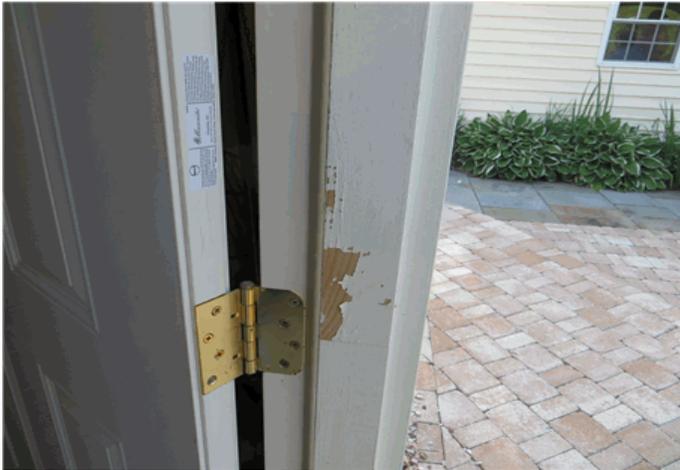
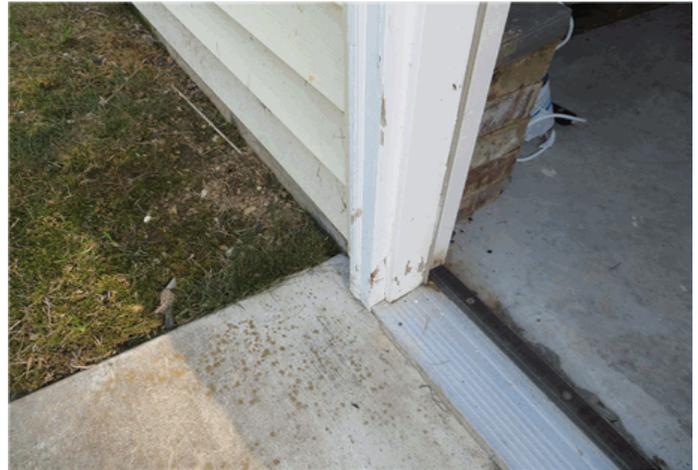
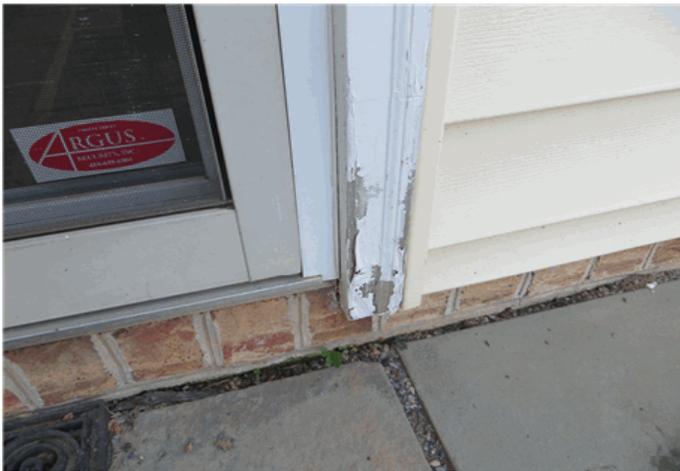
9) Exterior Door Conditions

The exterior door trim was weathered. Paint and/or maintenance is recommended.

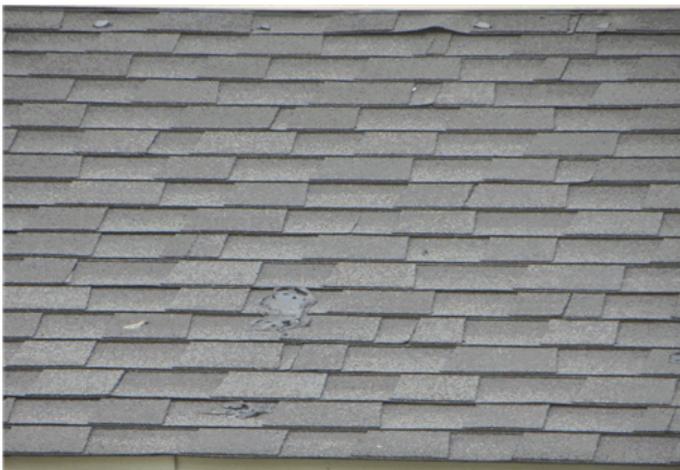
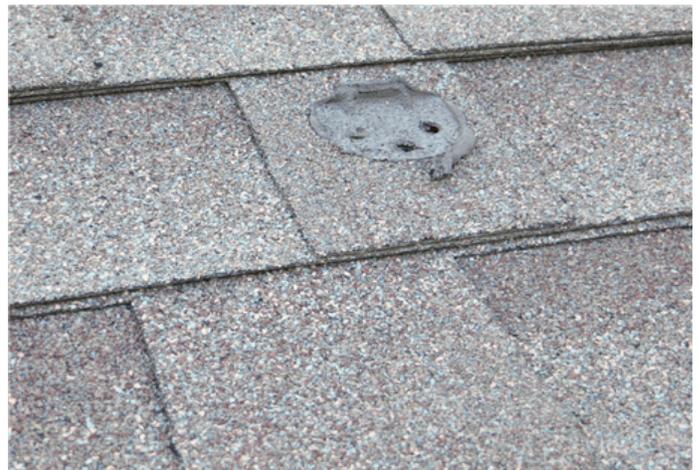
12) Roof Covering Condition	<div style="border: 1px solid black; padding: 2px; display: inline-block; margin-right: 10px;">R</div> <p>The roof covering shows normal or low wear for its age and appeared to be in serviceable condition at the time of the inspection. Damaged or missing shingles were observed at the back low roof near the satellite receiver. Recommend further evaluation and repair as needed by a qualified / licensed contractor. The inspector can not offer an opinion as to whether the roof leaks today unless it is moderately raining at the time of inspection. Client should obtain full disclosure / history information from the seller prior to close. The ridge vent system is coming loose in several locations. Recommend refastening. It is suggested that a "Licensed Roofing Contractor" be contacted for further evaluation and repair.</p>

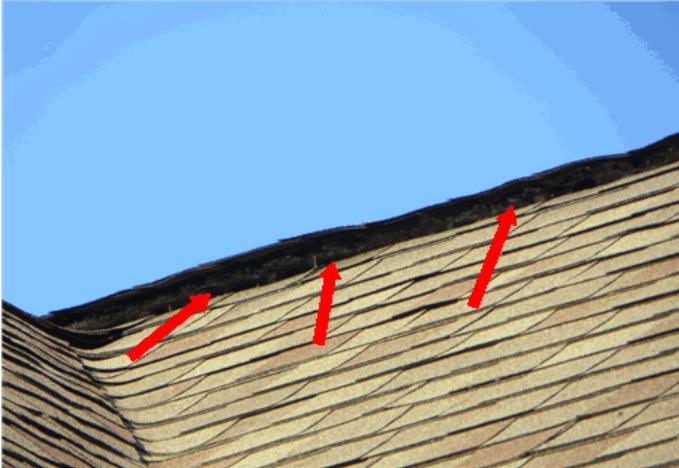
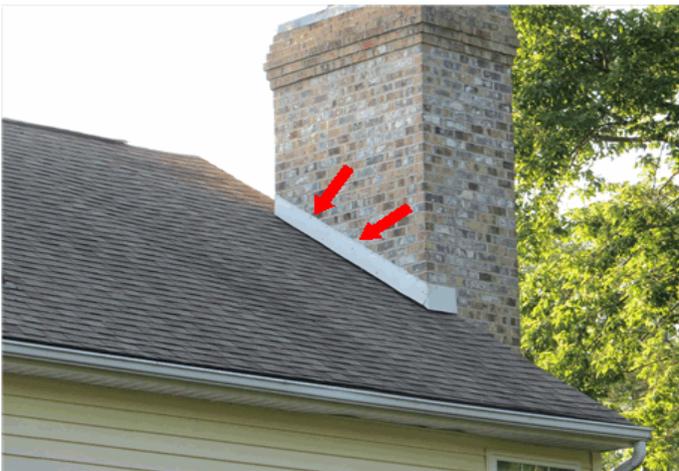
**13) Flashing Conditions****AS**

Recommend step counter flashing be installed and cut into the mortar joints at the chimney during the next roofing change. At this point the current caulk line must be maintained to prevent water penetration.

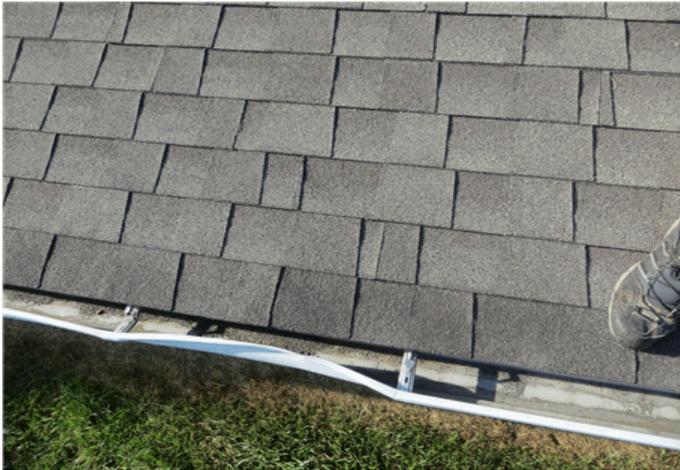
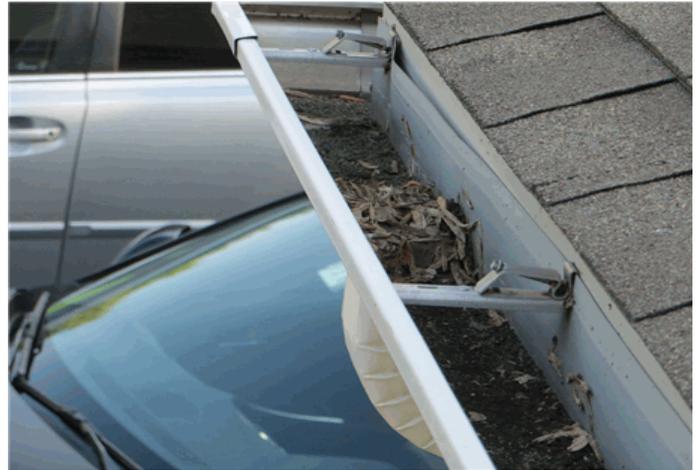
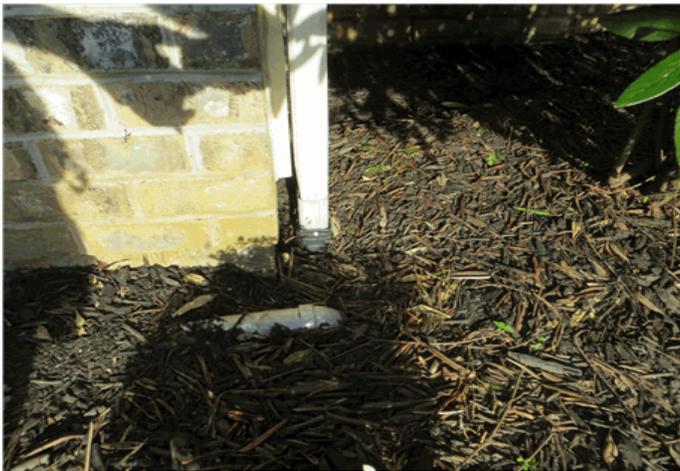
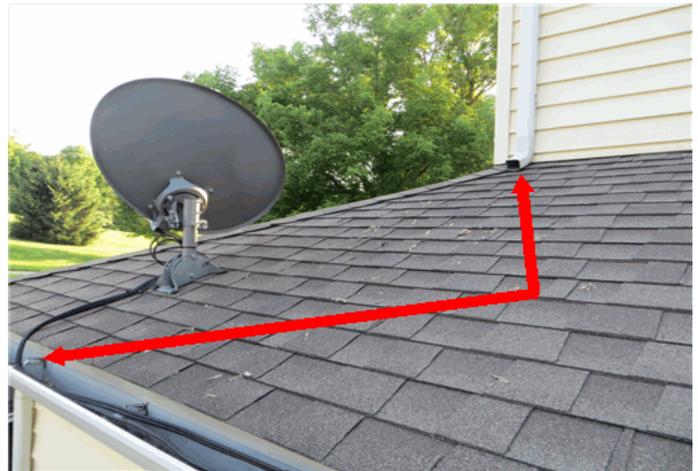
**14) Gutter & Downspout Conditions****R**

The gutters had leaves and debris clogging the downspouts at the time of the inspection. Suggest cleaning and removal of debris on a regular basis. Damaged gutter on low garage roof. Recommend repairs as needed. Sub-surface drains were observed. These drains were not tested as a part of this inspection. Condition of underground pipes or location of their termination points (if any) is not determined as part of this inspection. Some evidence of these drains not functioning properly was observed. Recommend efforts to shed the water from the foundation area. Recommend connecting the downspout that empties on the roof directly to the existing gutter system

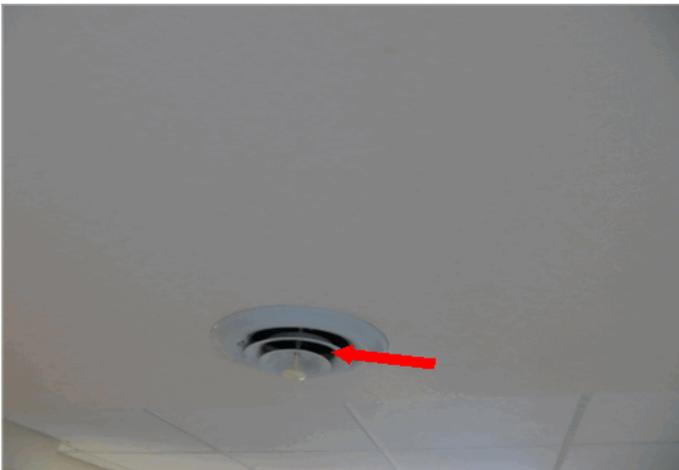
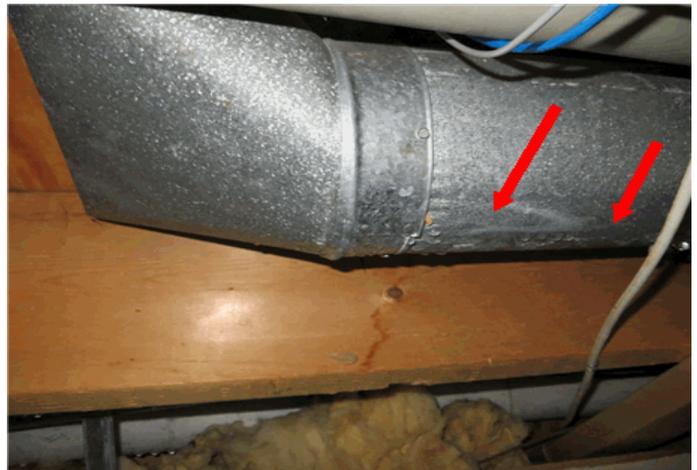
18) Distribution Conditions

R Recommend removal of the direct taps on the trunk line and return for better overall air flow. Some ductwork was condensing and dripping onto the drop ceiling. Recommend insulating. It is suggested that a "Licensed HVAC Contractor" be contacted for further evaluation and repair.

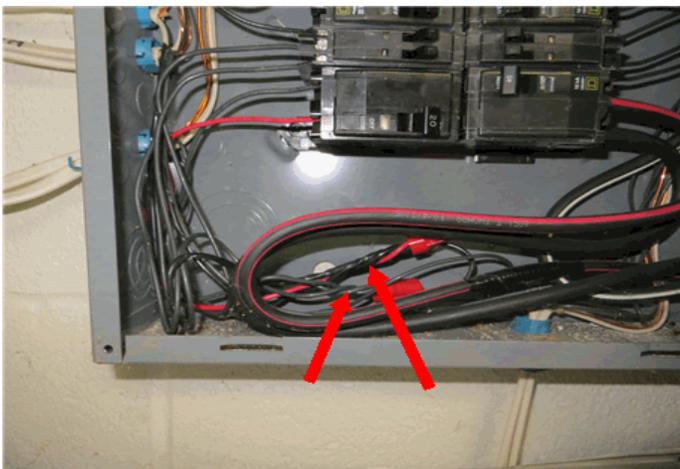
24) Electrical Panel Conditions S Two or more circuits were connected to one breaker in the panel. This condition can add to the load of the affected electrical circuits causing a possible overload, tripping, or arcing at the breaker(s). Current standards require circuits to be independently protected. Recommend an electrician properly separate circuits.

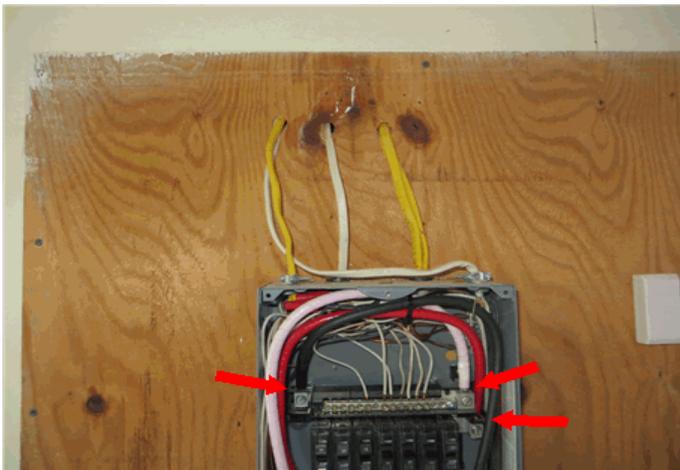
25) Sub panel Conditions

The sub panel appeared to be in serviceable condition at the time of inspection. Recommend an anti-oxidant material be applied by a licensed electrician to wires and / or main terminal lug connection to reduce rust, corrosion or oxidation of exposed wires

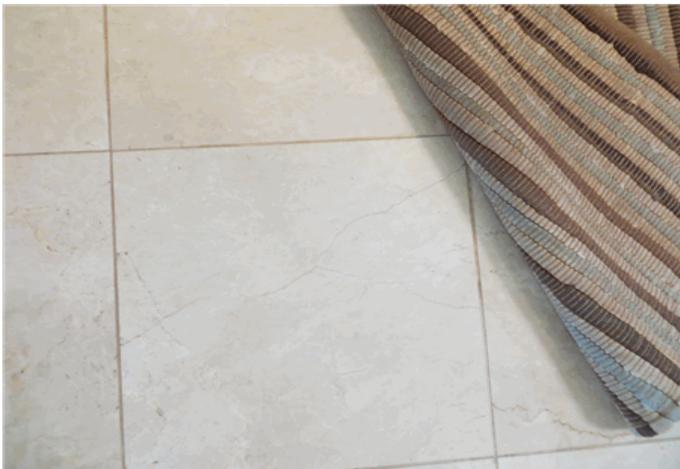
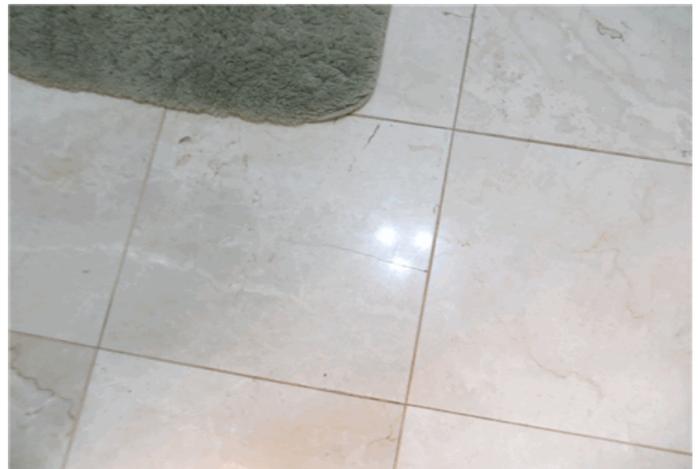
32) Floor Conditions

Cracked floor tiles were observed in the master bath. Recommend repair as needed.

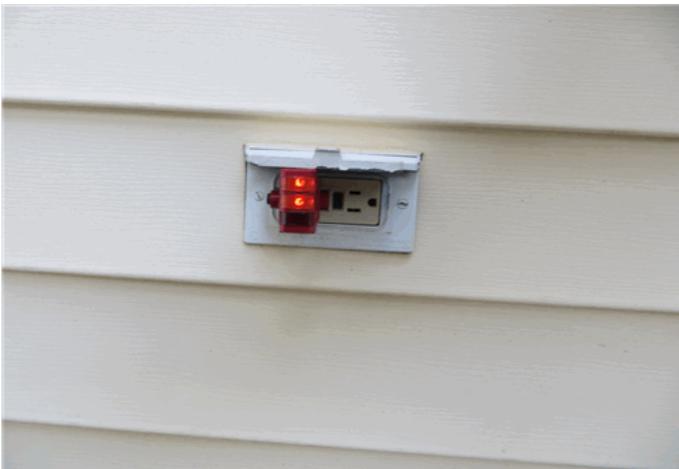
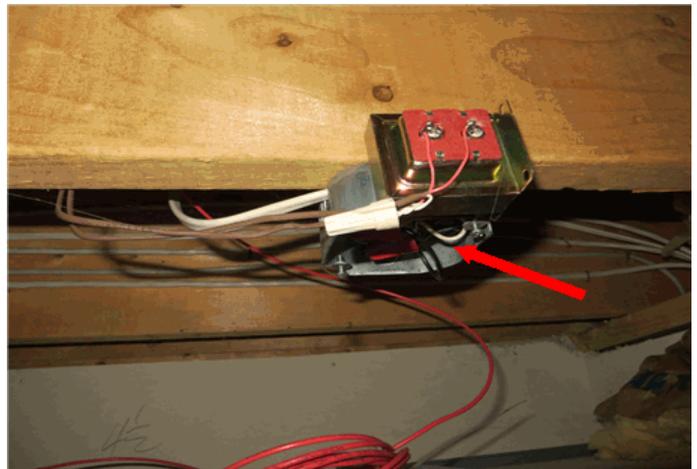
36) Electrical Conditions

The GFCI (ground fault interrupter circuit) receptacle did not respond to the inspectors (external) trip test device at the back exterior outlet. Replacement and / or repair is needed. Recommend further evaluation and / or repair by a licensed electrician prior to close. Junction box cover was missing at the basement ceiling near the stairs. Recommend installation of covers for increased safety. Missing receptacle or switch covers were observed at the garage, and under the sink. Recommend covers be installed for safety.

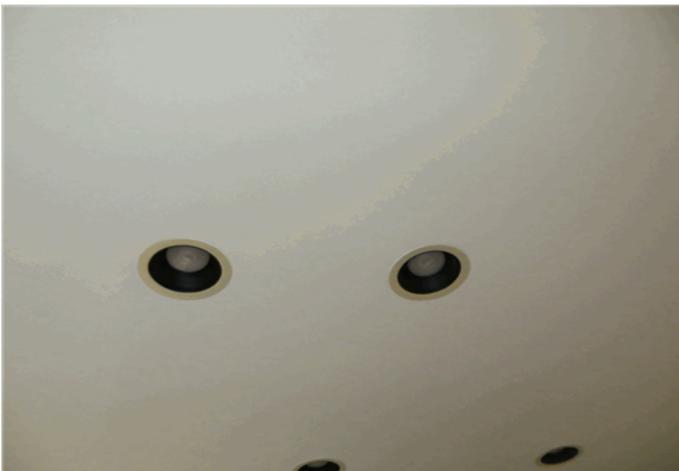
37) Lighting Conditions

The island lights were out or inoperative at. (Possibly the switch) Dismantling and testing of all light fixtures is not performed as part of this inspection. Recommend all lights be operable prior to close.

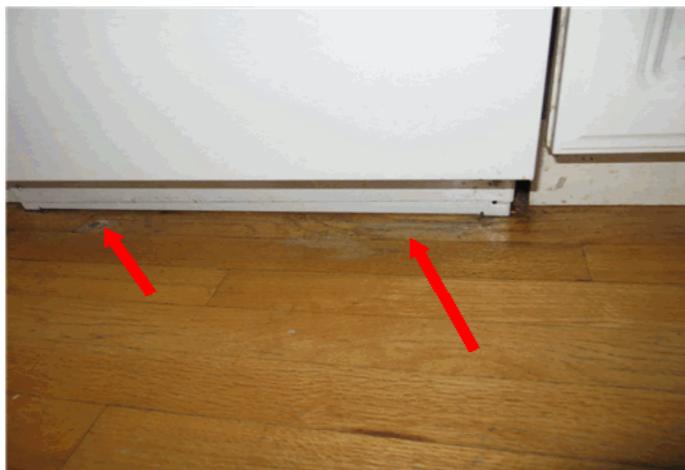
43) Floor Conditions

The general condition of the visible and accessible portions of the floors appeared to be in serviceable condition at the time of the inspection. Some water staining near the dishwasher.

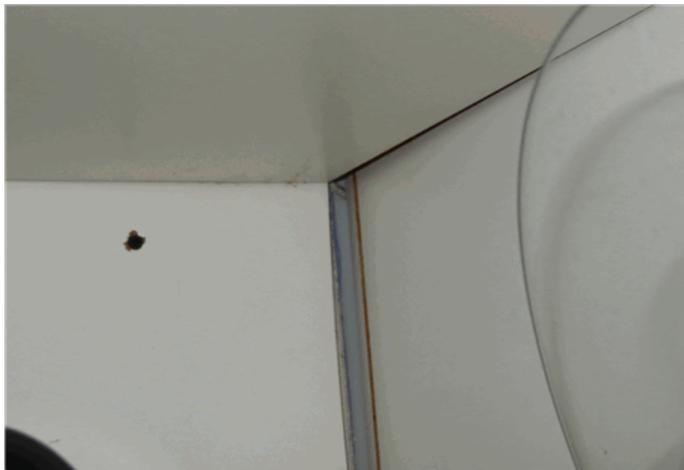
49) Cabinet Conditions

The kitchen oven cabinet was damaged. Recommend repair and / or replacement. It is suggested that a "Licensed General Contractor" be contacted for further evaluation and repair.

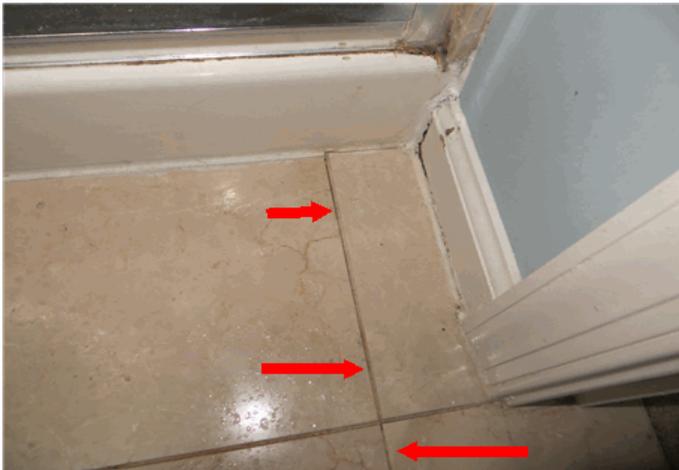
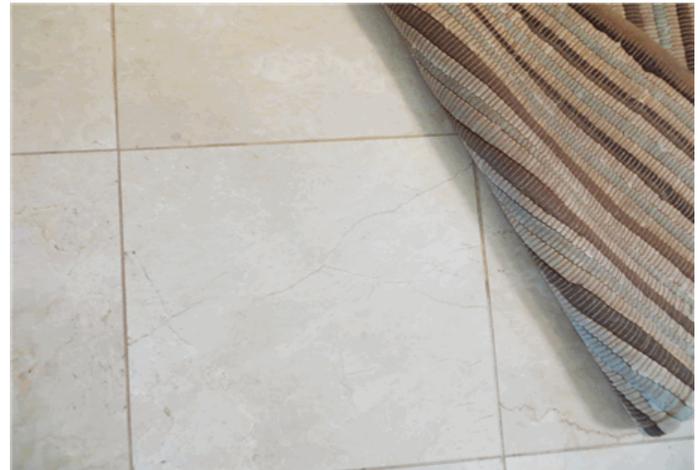
57) Floor Conditions

Tiles had loose or missing grout at the shower in the master. Recommend proper tile work by a qualified contractor. Cracked floor tiles were also observed. Recommend repair as needed. It is suggested that a "Licensed General Contractor" be contacted for further evaluation and repair.

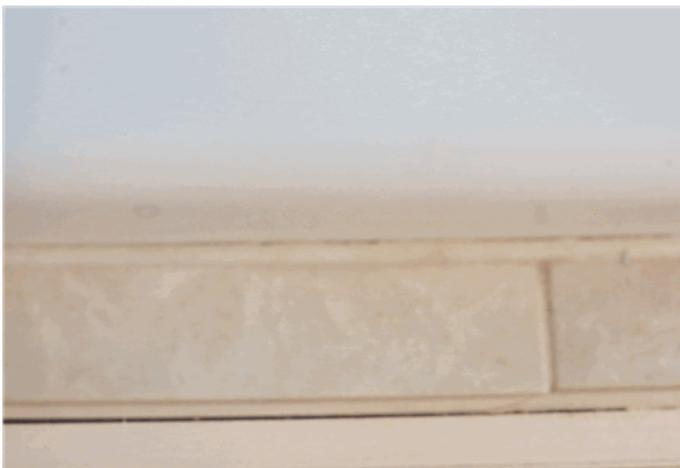
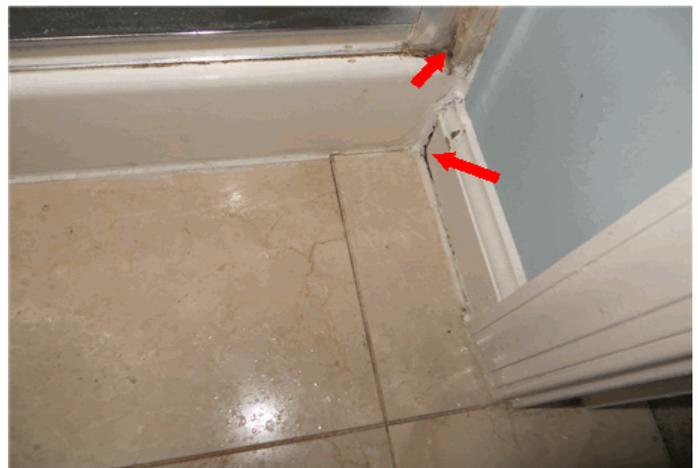
65) Shower - Tub Conditions

Caulking is recommended at the jetted tub and around the shower pan in the master bath. Conditions behind wall or under floor were concealed and not visible or accessible for inspection. Shower head connection was leaking at the time of the inspection. Recommend repair as needed.

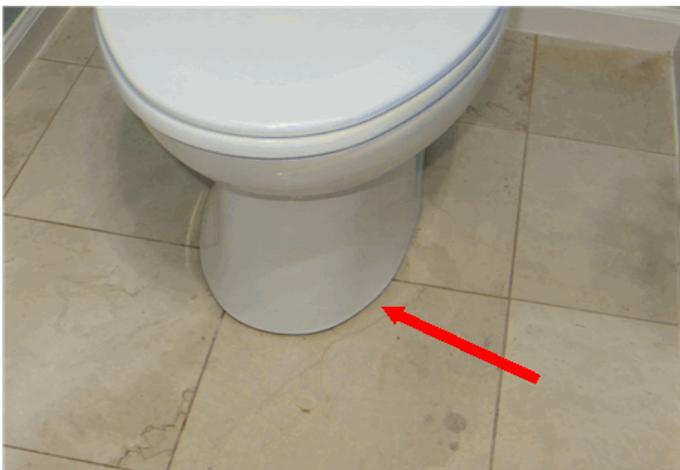
66) Toilet Conditions

The toilet was loose at the floor in the master bath . Recommend securing / repair as needed. While this condition is somewhat common, it can increase the likelihood that some water penetration may have occurred at the base / wax seal area of the floor. It is suggested that a "Licensed Plumbing Contractor" be contacted for further evaluation and repair.

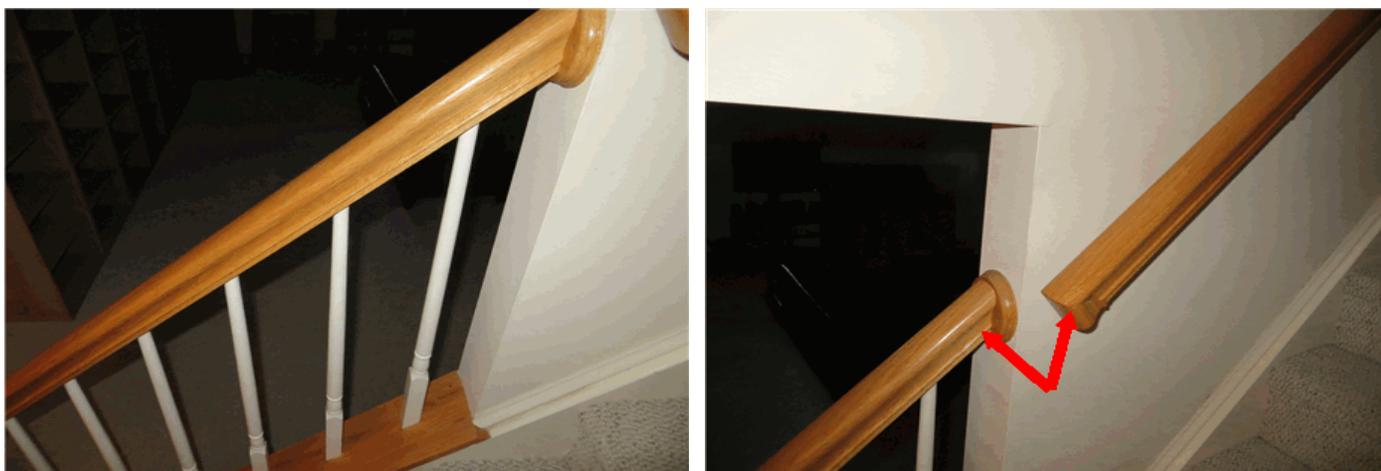
67) Basement Stair Conditions

The openings in the stair area railings appear too wide. Although this may have been proper at the time of construction, we recommend decreasing the opening length between the railings to reduce to less than 3 3/4 the possibility of child injury and for increased safety. Client should consult a qualified contractor for information on modern safety standards. By today's standards the handrail should also be continuous. It is suggested that a "Licensed General Contractor" be contacted for further evaluation and repair.

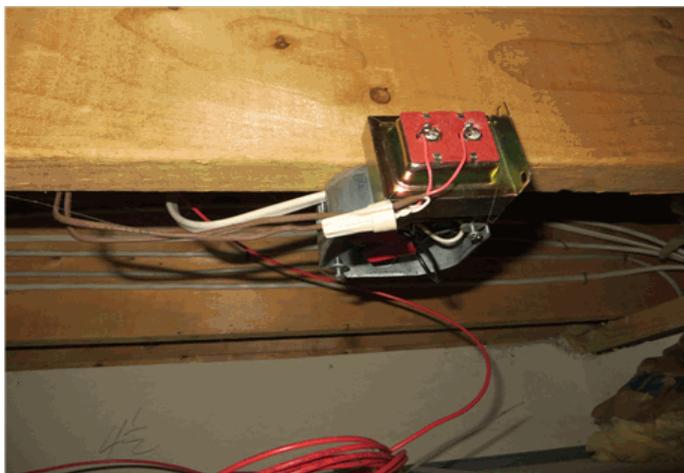
Junction or switch box cover was missing at the ceiling near the stairs. Recommend installation of covers for increased safety.

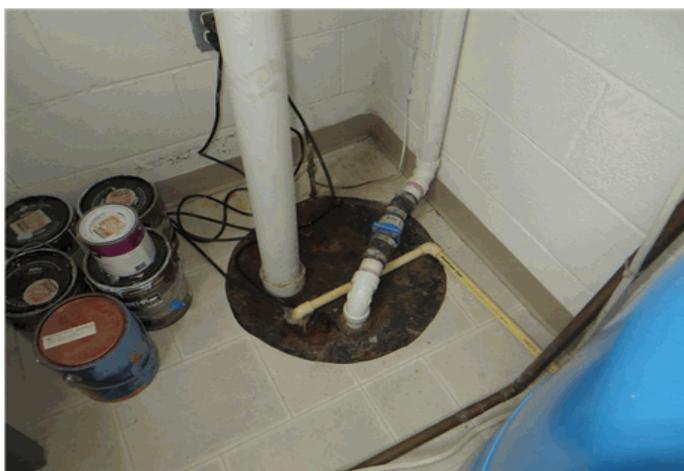
The sump pit was sealed closed. The inspector is prohibited from disturbing the seal. The inspector was unable to inspect pit and / or pump (if present). Laundry room cover was rusted. The furnace area sump pump discharge may be piped into the main waste line. Since this is generally considered improper by most townships, the sump should be piped to the exterior of the home. It is suggested that a "Licensed Plumbing Contractor" be contacted for further evaluation and repair.

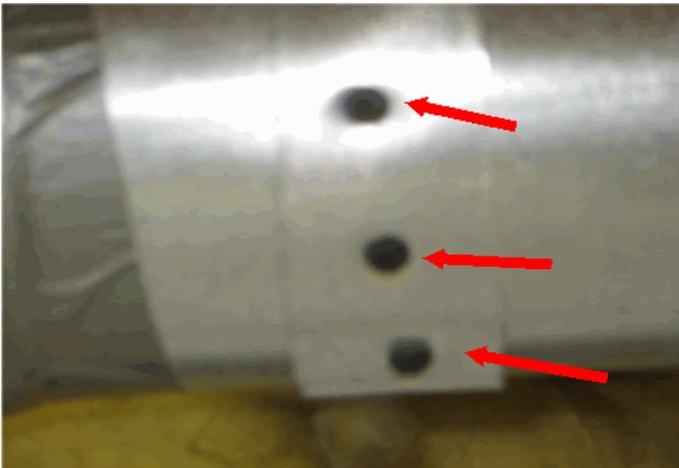
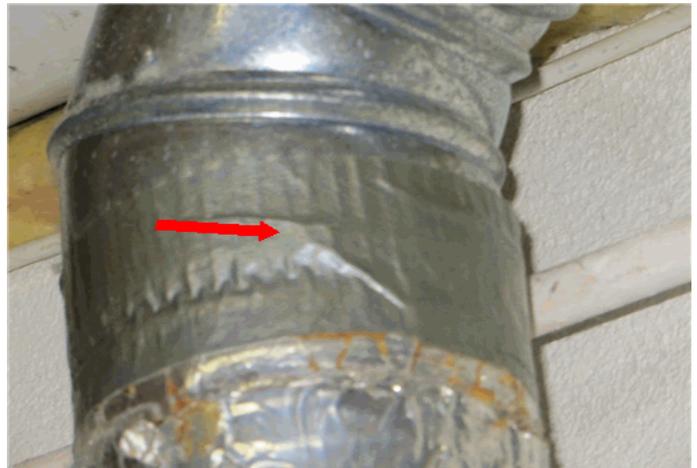
Recommend removing the screws from the dryer vent for safety. The screws can collect lint and poses a fire hazard. Recommend removal and sealing of the unused dryer vent.

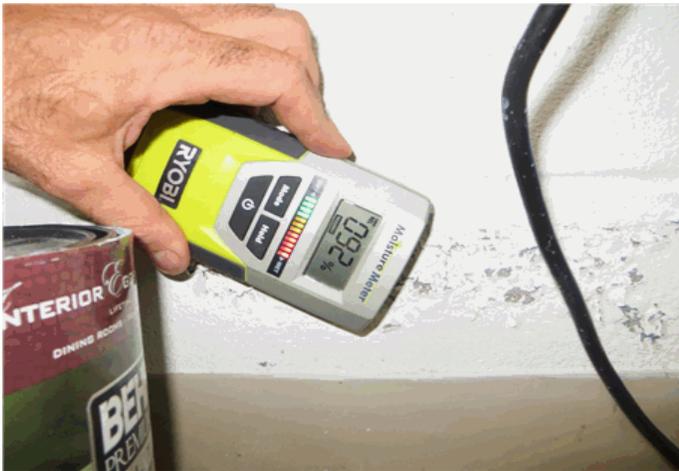
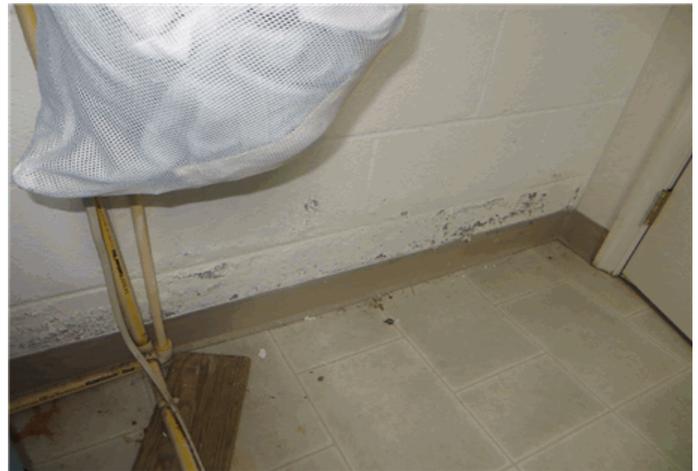
Excessive amounts of moisture were observed in the stairway from the basement to the garage. Additional ventilation and / or a sealant should be considered. The conditions observed are conducive to wood rot, mold, rust and corrosion. Recommend further evaluation by a contractor. A mold inspection or testing was not performed as part of this general home inspection. Moisture stains were observed at the foundation walls. We suspect recent or active water penetration. Client should obtain history / disclosure information from seller and / or consult a waterproofing contractor.
