Inspection Report

Inspector: Jason Hornung

123 Anywhere Road

Your town, Md

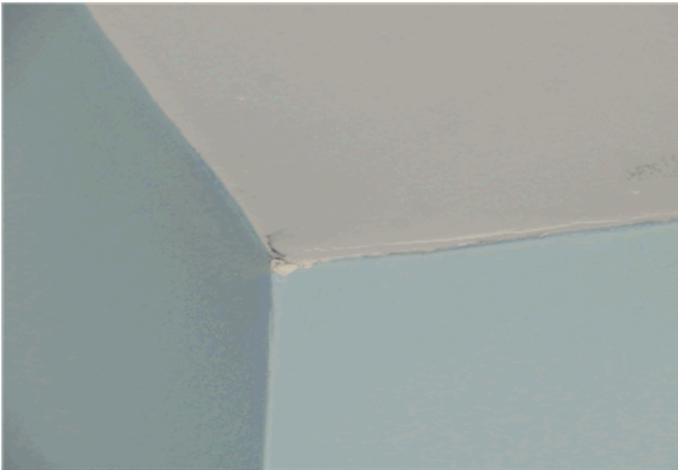
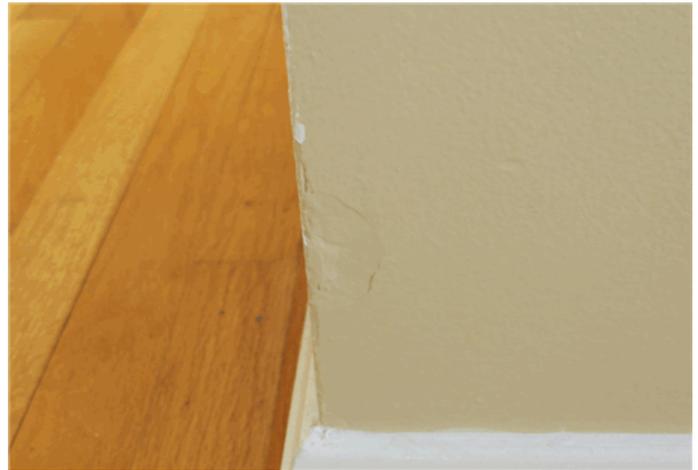
The walls appeared to be freshly painted. This condition may hide, mask, or conceal previous conditions that may have existed. There were common / typical settlement type cracks, blemishes, and nail pops observed to the interior walls.

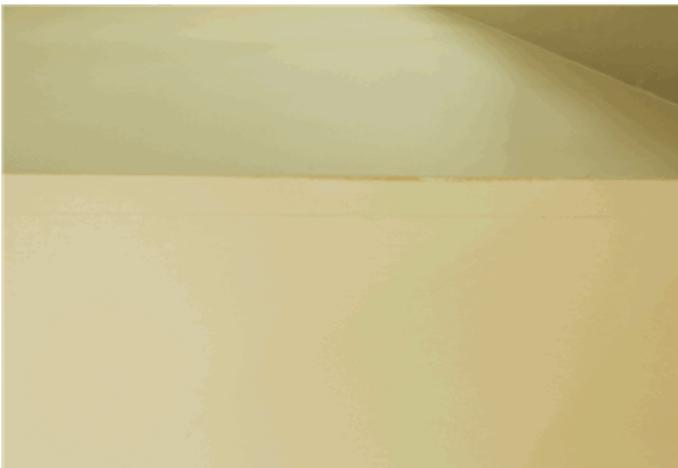
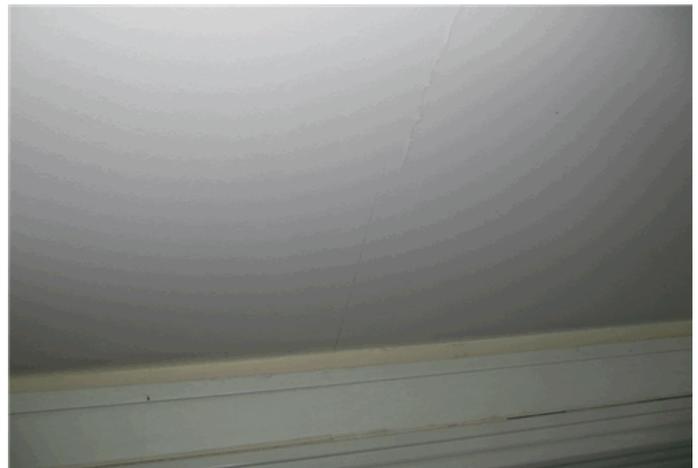
**31) Ceiling Conditions**

The ceilings appeared to be freshly painted. This condition may hide, mask, or conceal previous conditions not visible at the time of this inspection. Common cracks, blemishes, and nail pops were observed at the time of the inspection.

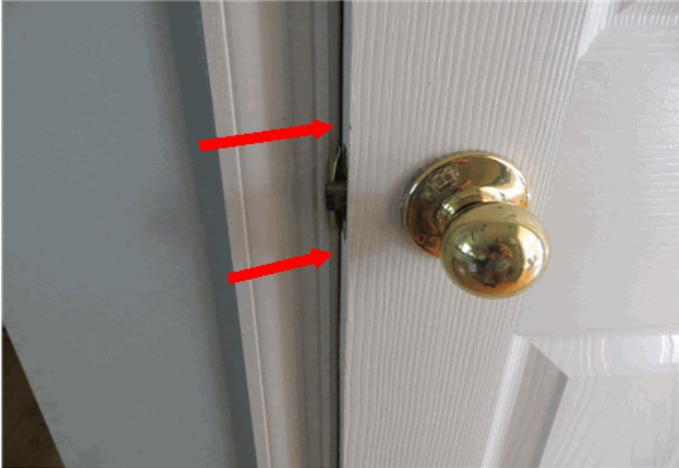
The doors stick at the door frame at the kitchen pantry. Repairs and / or adjustments are recommended.
